Manhole Inspection Summary

Manhole # S19GG_008MH

Insp Date: **6/13/07 9:38 AM**

Location Address: **1600 PULASKI ST**

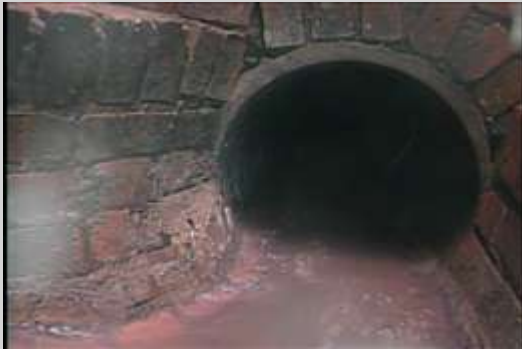
12 O'Clock Outflow

15 in. Circular Gravity Sewer
Pipe Out @ 12 O'Clock

Pipe Height: **15.6** (in.) Rod and Bar (Angled)
Pipe Material: **Clay** ☐ Pipe Lined
Invert Depth: **12.54** (ft.) Flow Characteristics: **Slow**
Deposits: ☒ None ☐ Mud ☐ Sludge ☐ Debris ☐ Grease
Silt Depth: (in.) Deposits Extent:
Infiltration: **None** Pipe Seal Cond: **Sound**

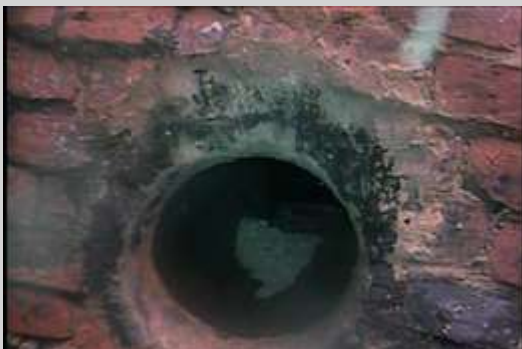
4 O'Clock Inflow

8 in. Circular Gravity Sewer
Pipe In @ 4 O'Clock

Pipe Height: **8.4** (in.) Rod and Bar (Angled)
Pipe Material: **Clay** ☐ Pipe Lined
Invert Depth: **7.32** (ft.) Flow Characteristics: **Slow**
Deposits: ☒ None ☐ Mud ☐ Sludge ☐ Debris ☐ Grease
Silt Depth: (in.) Deposits Extent:
Infiltration: **None** Pipe Seal Cond: **Sound**

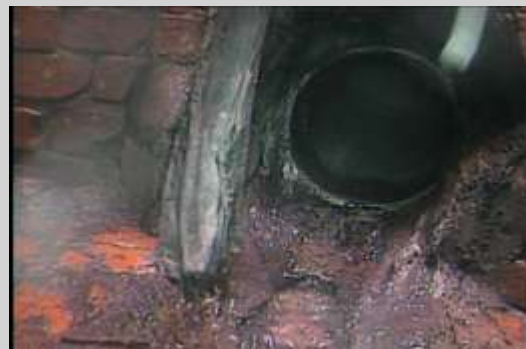
Drop In @ 4 O'Clock

Drop: **Outside** Rod and Bar
Angled: **Yes** Reading: **10.31** (ft.)
Inv Depth: **11.31** (ft.)
Drop Condition: **Open**

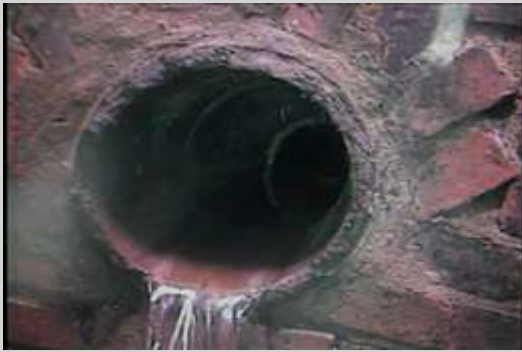
6 O'Clock Inflow

8 in. Circular Gravity Sewer

Pipe In @ 6 O'Clock

Drop In @ 6 O'Clock

Infiltration: **None** Pipe Seal Cond: **Sound**

Drop: **Outside** Rod and Bar

Drop Condition: **Clogged**

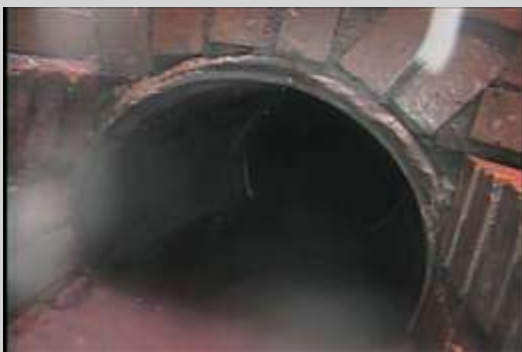
9 O'Clock Inflow

15 in. Circular Gravity Sewer

Pipe In @ 9 O'Clock

Infiltration: **None** Pipe Seal Cond: **Sound**
